2012
New Hampshire Department of Agriculture, Market & Food
Invasive Species Control Project for
Highway Right-of-Ways

Re: ROW Special Permit #SP-163

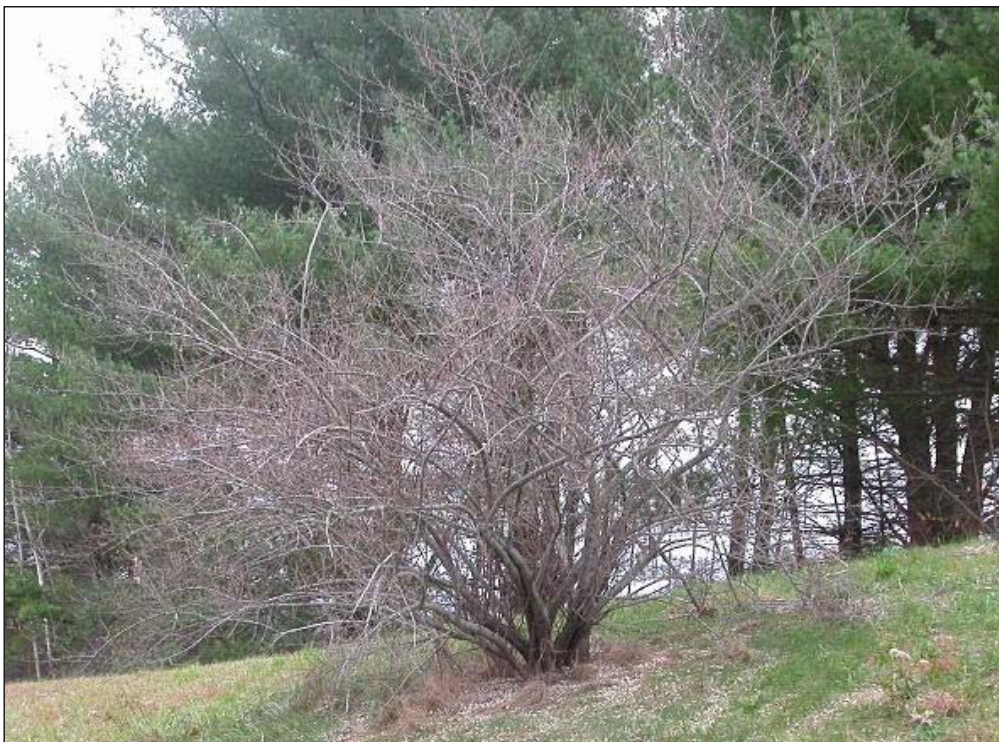
Photo 1 – Showing one of many Autumn olive, *Elaeagnus umbellata*, shrubs treated using the Low Volume Basal Bark method that resulted in 100% dieback. This particular shrub is located in the ROW for I-393 heading eastbound where Exit 3 off-ramp (for Rte 106) diverges.

(Photo taken on November 1, 2012)

Based on visual inspections within the last few weeks, the results of this project appear to be very positive with approximately 85% of woody invasives treated showing complete mortality (Photo 1), and the remaining 15% exhibiting extensive, but not complete, dieback (Photo 2). The dominant invasive shrubs were large, mature, multi-stemmed Autumn olives with low branching habits. This characteristic appears to have impeded or slowed the immediate efficacy of the treatments. Given time, it is possible that the herbicide will have more of an affect on these plants during the winter months and become evident next spring. Follow up monitoring will continue next year and, where necessary, subsequent treatments will be applied (pending approval of 2013 Special Permit).

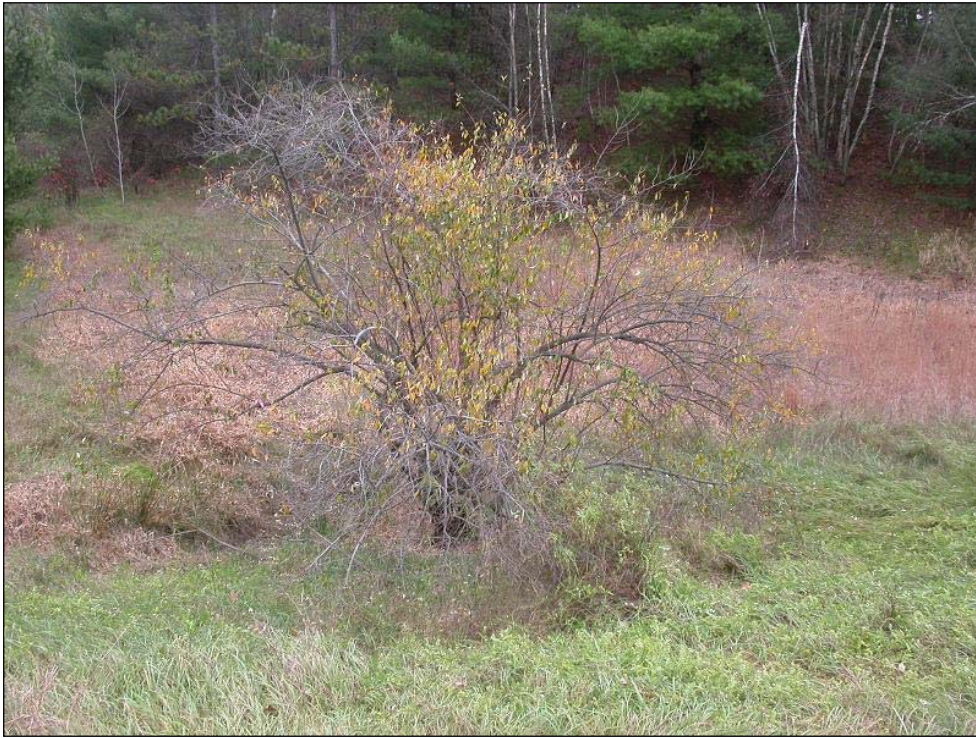
Photo 2 – Shows one of the few Autumn olive shrubs that comprises the 15% that did not completely die. This example has at least one branch still retaining its foliage, which exhibits yellowing and, therefore, may be symptomatic. This shrub is located in the ROW for Rte 106 heading northbound just past the I-393 interchange.

(Photo taken on November 1, 2012)

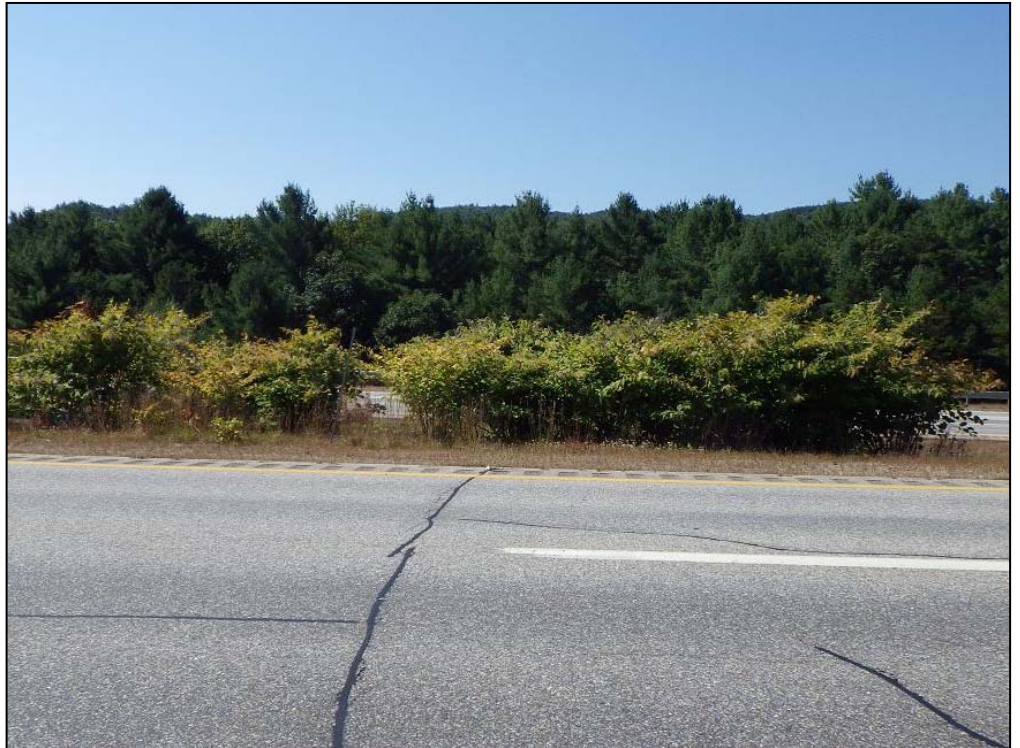
Photo 3 – Numerous dense stands of Japanese knotweed, *Polygonum cuspidatum*, growing the median of I-93 just north of Exit 24 in Ashland.

(Photo taken on September 17, 2012)

In several locations, Japanese knotweed formed very large, tall, dense thickets (Photo 3), and therefore, a mist blower was used to deliver a 4-5% solution of Roundup-Pro (a.i. glyphosate) to thoroughly wet the foliage. Some of the larger populations measured -20' in depth by -50' in length by 7-8' tall. These dense stands made it difficult to treat, even with a mist blower, to ensure full herbicide penetration and coverage all the way to the center. Other smaller populations were treated using a Solo hand-pump backpack sprayer with a flat-fan nozzle. All Japanese knotweed treatments occurred post flowering period to avoid foraging honeybees. Applications done this time of year also coincide with the downward movement of carbohydrates into the knotweed's rooting system for overwintering and spring rejuvenation. However, waiting till after flowering significantly reduces the period of time when Japanese knotweed can be treated (-2-4 weeks), especially when applications are being done on a statewide level.

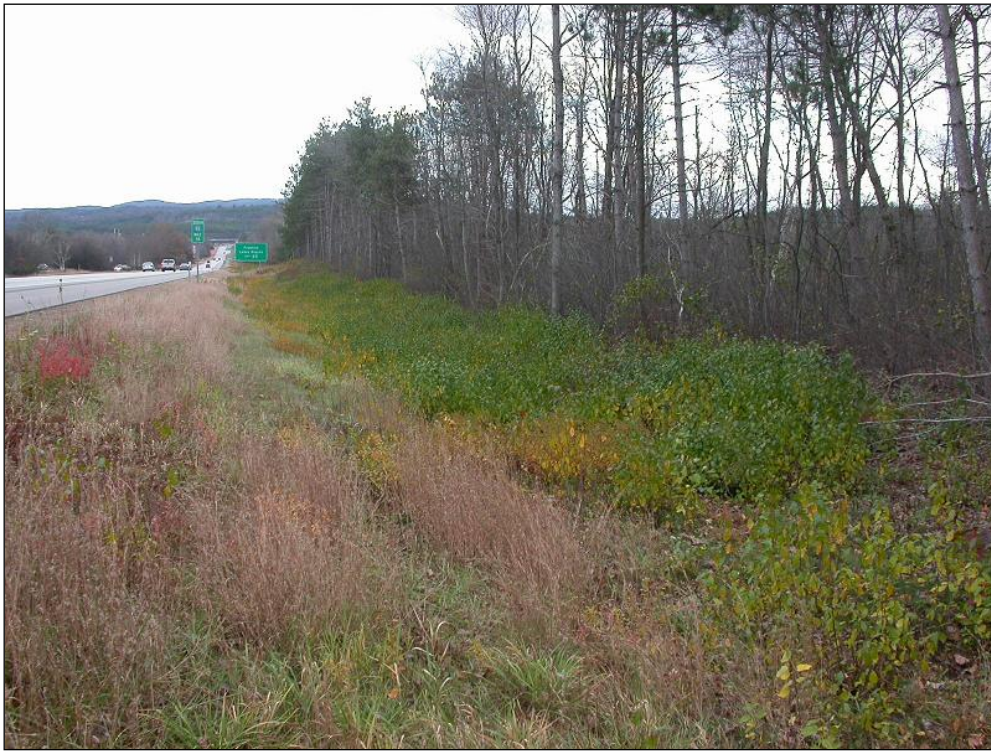
Photo 4 – Monoculture of Glossy buckthorn seedlings and saplings occurring along the I-93 southbound right-of-way. Note that grasses and other native plants have gone into dormancy.

(Photo taken on November 5, 2012)

Along I-93 north of Exit 20 in Tilton there are dense monocultures of Glossy buckthorn, *Rhamnus frangula*, occurring in the right-of-way and median areas (Photo 4). The majority of which are in the seedling or sapling stage making it somewhat easy to treat them using a foliar application method. Since Glossy buckthorn retains it's foliage longer into the fall than most native species it allowed glyphosate to be used with minimal off target impacts to grasses and other dormant ground covers. Most of these invasive woody shrubs are small, single stemmed saplings. Their relatively young age and short height (<3' tall) made them conducive to being treated using a foliar spray of Roundup Pro Concentrate.

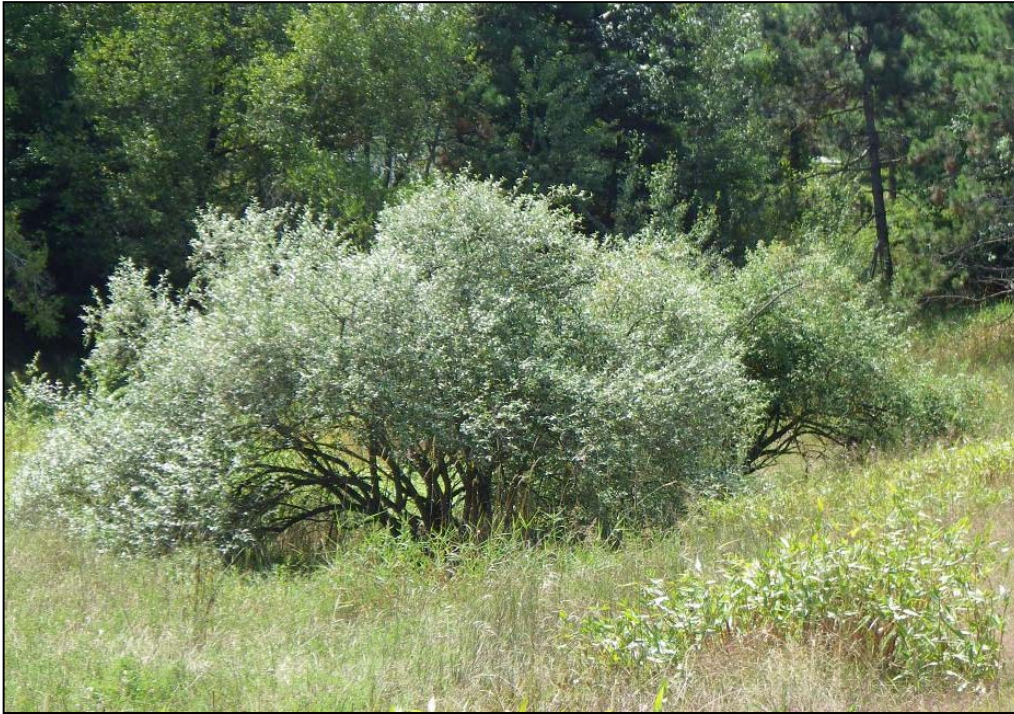
BEFORE

Large, mature Autumn olive shrub prior to herbicide treatment. Located off of Rte 106 near I-393 interchange.

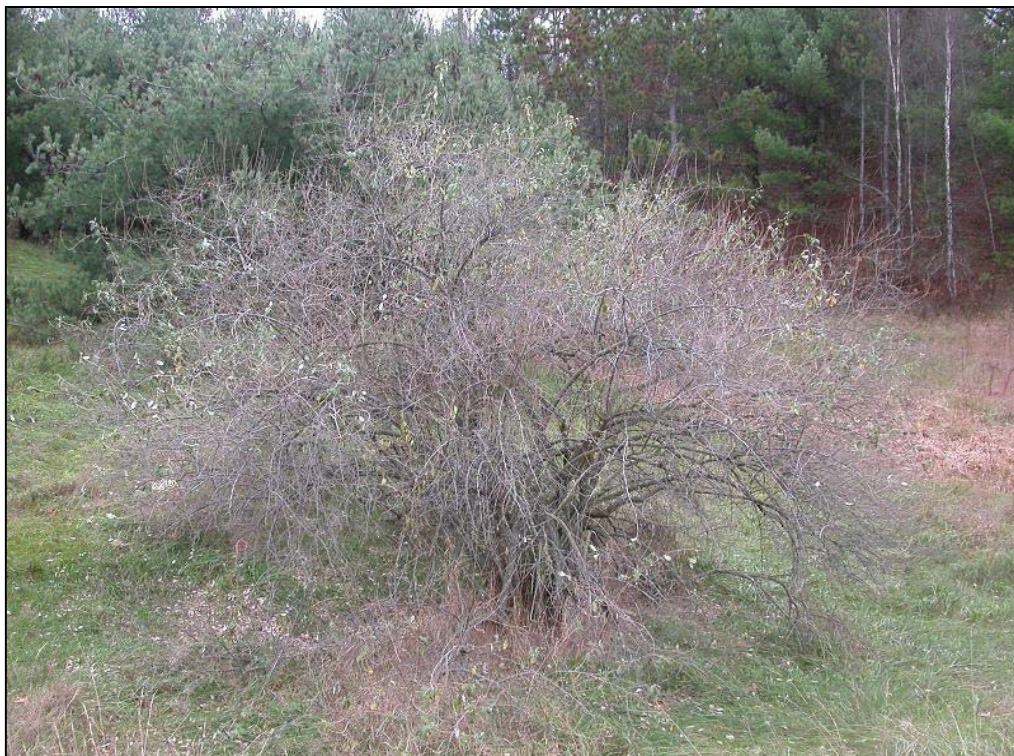
AFTER

The same Autumn olive as pictured above, but taken 3-weeks following herbicide treatment.
